POLYMERIC POSITIVE EXPULSION  
BLADDERS FOR LIQUID OXYGEN SYSTEMS

Contract NAS 3-7952

THE BOEING COMPANY

June 1968

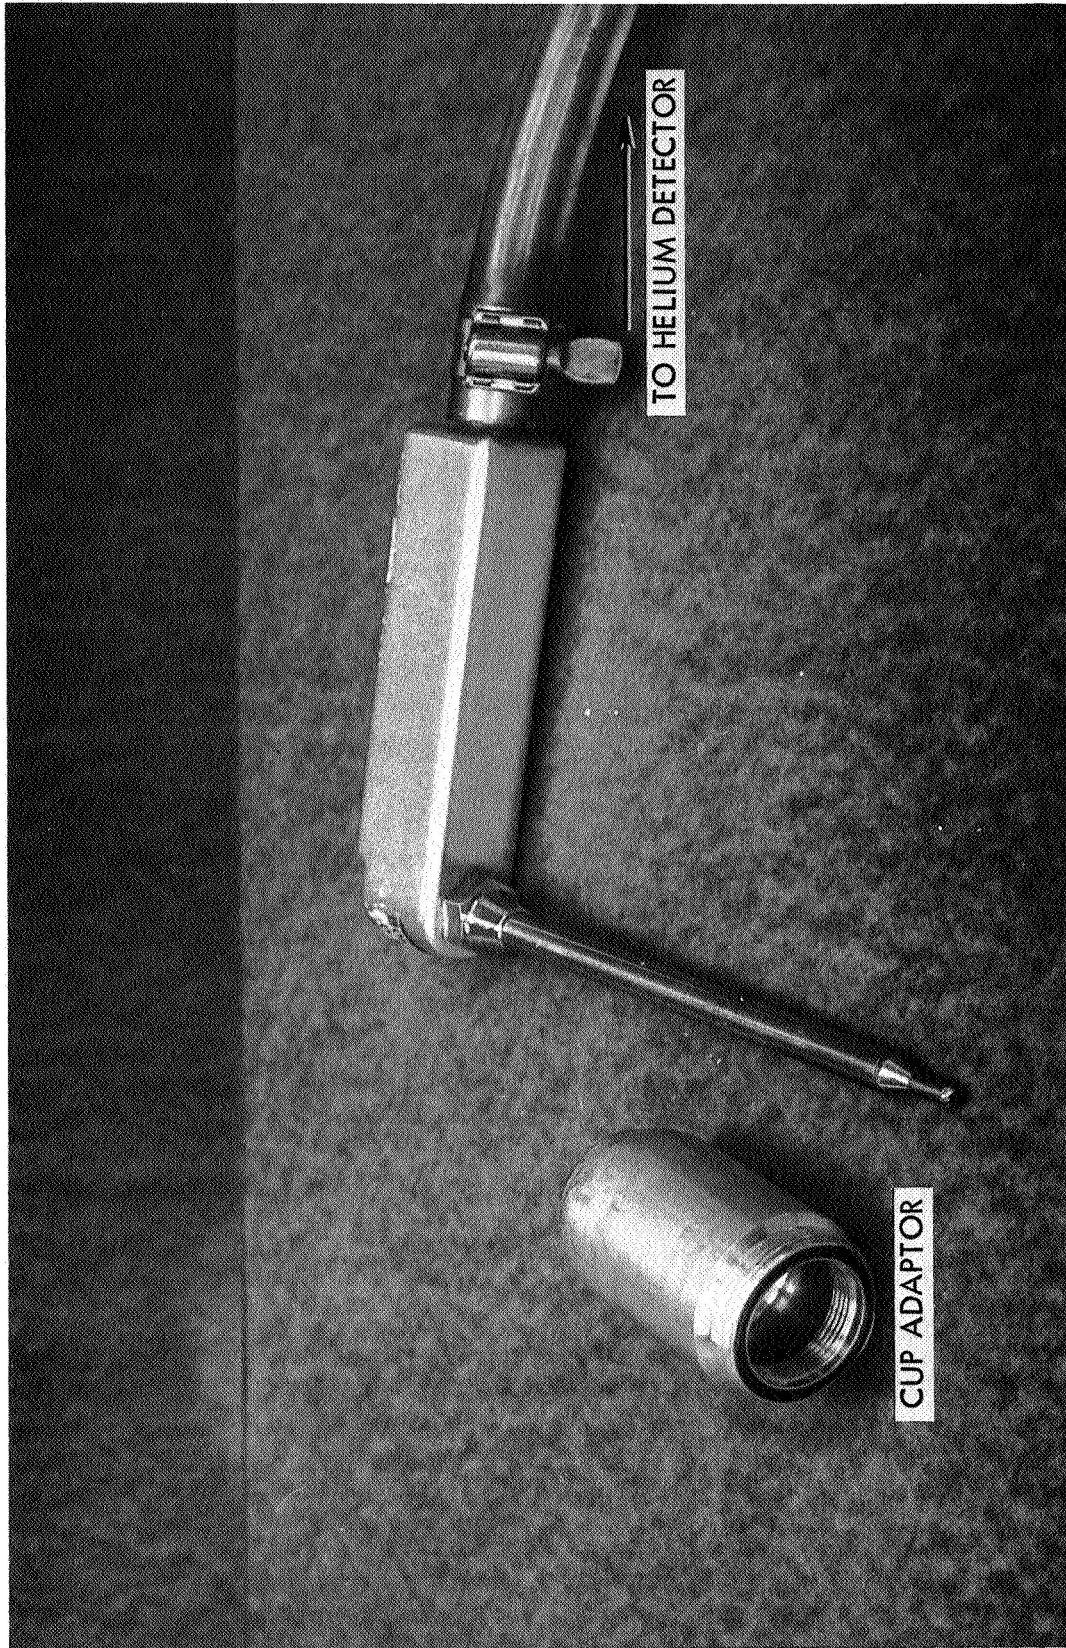
FIGURE 12 HELIUM LEAK DETECTOR NOZZLE HEAD

To perform the leak checks, a standard mass spectrometer, Model 24-120A, manufactured by Consolidated Electrodynamics Corporation was used. A zero division rise on the X-1 scale (or less than  $2 \times 10^{-10}$  std cc/sec) was used for acceptance. The probe was modified by adding a cup to the end of the probe as shown in Figure 12. The cup, 1.25 in<sup>2</sup> in cross-sectional area, enabled the operator to measure the helium leakage rate over a known surface area. Consequently, with the known area, the mass spectrometer measured to an acceptance level of  $1.6 \times 10^{-10}$  cc/sec/in<sup>2</sup>. The cup was held in one location for 1 to 3 seconds during the checks. If held for extended period of time, the equipment would begin to register the gaseous permeability of the film material.

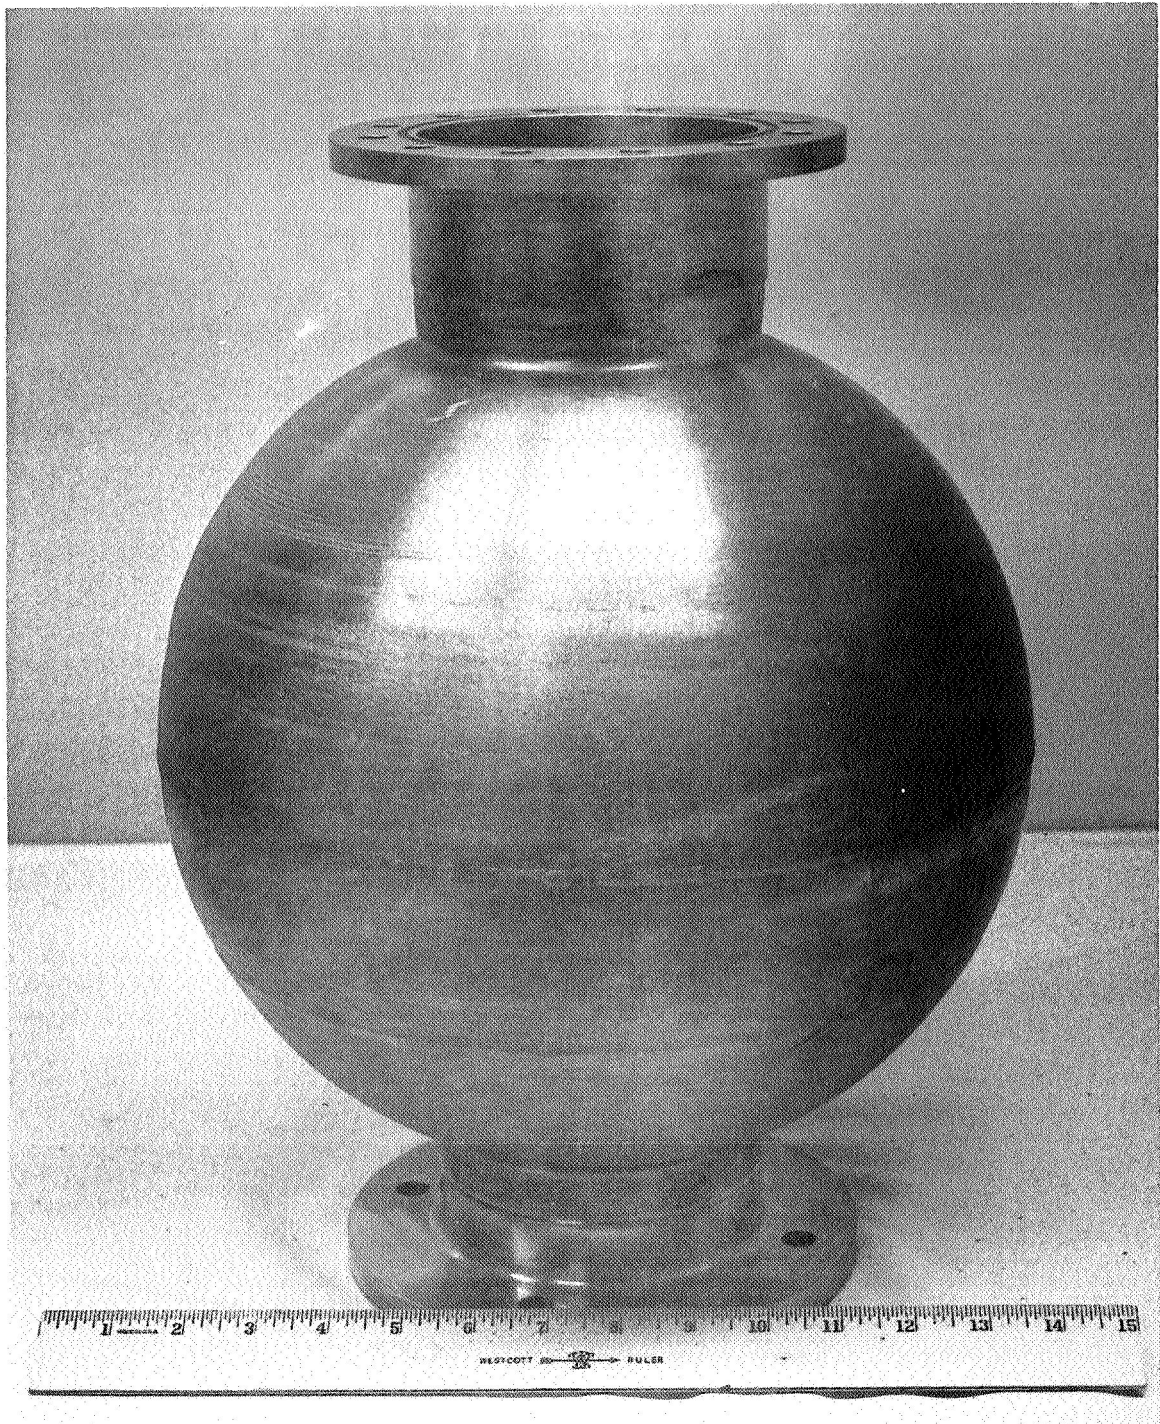
FIGURE 19 STEEL TEST TANK WITHOUT FITTINGS

3.2.4.1 Test Tank - The test chamber was a spherical stainless steel (AISI 321 CRÉS) tank with an inside diameter of  $12^{+.030}_{-.000}$  inches and a minimum wall thickness of .07. The upper and lower flanges were 3003 aluminum alloy and the standpipe and all bladder fittings were 6061-T4 aluminum alloy. The tank was designed for a room temperature burst pressure of 265 psi. The tank was proof tested to 200 psi.

The tank (Figures 18 and 19) was designed for inward expulsion. It features provisions for filling from either the top or the bottom fitting; venting and expulsion from the top fitting; and helium pressurization and venting (to the exterior of the bladder) through the top flange. Teflon or Creavey seals were used at all flange areas to prevent leakage. The upper flange, bladder fitting and standpipe are shown in Figure 20.

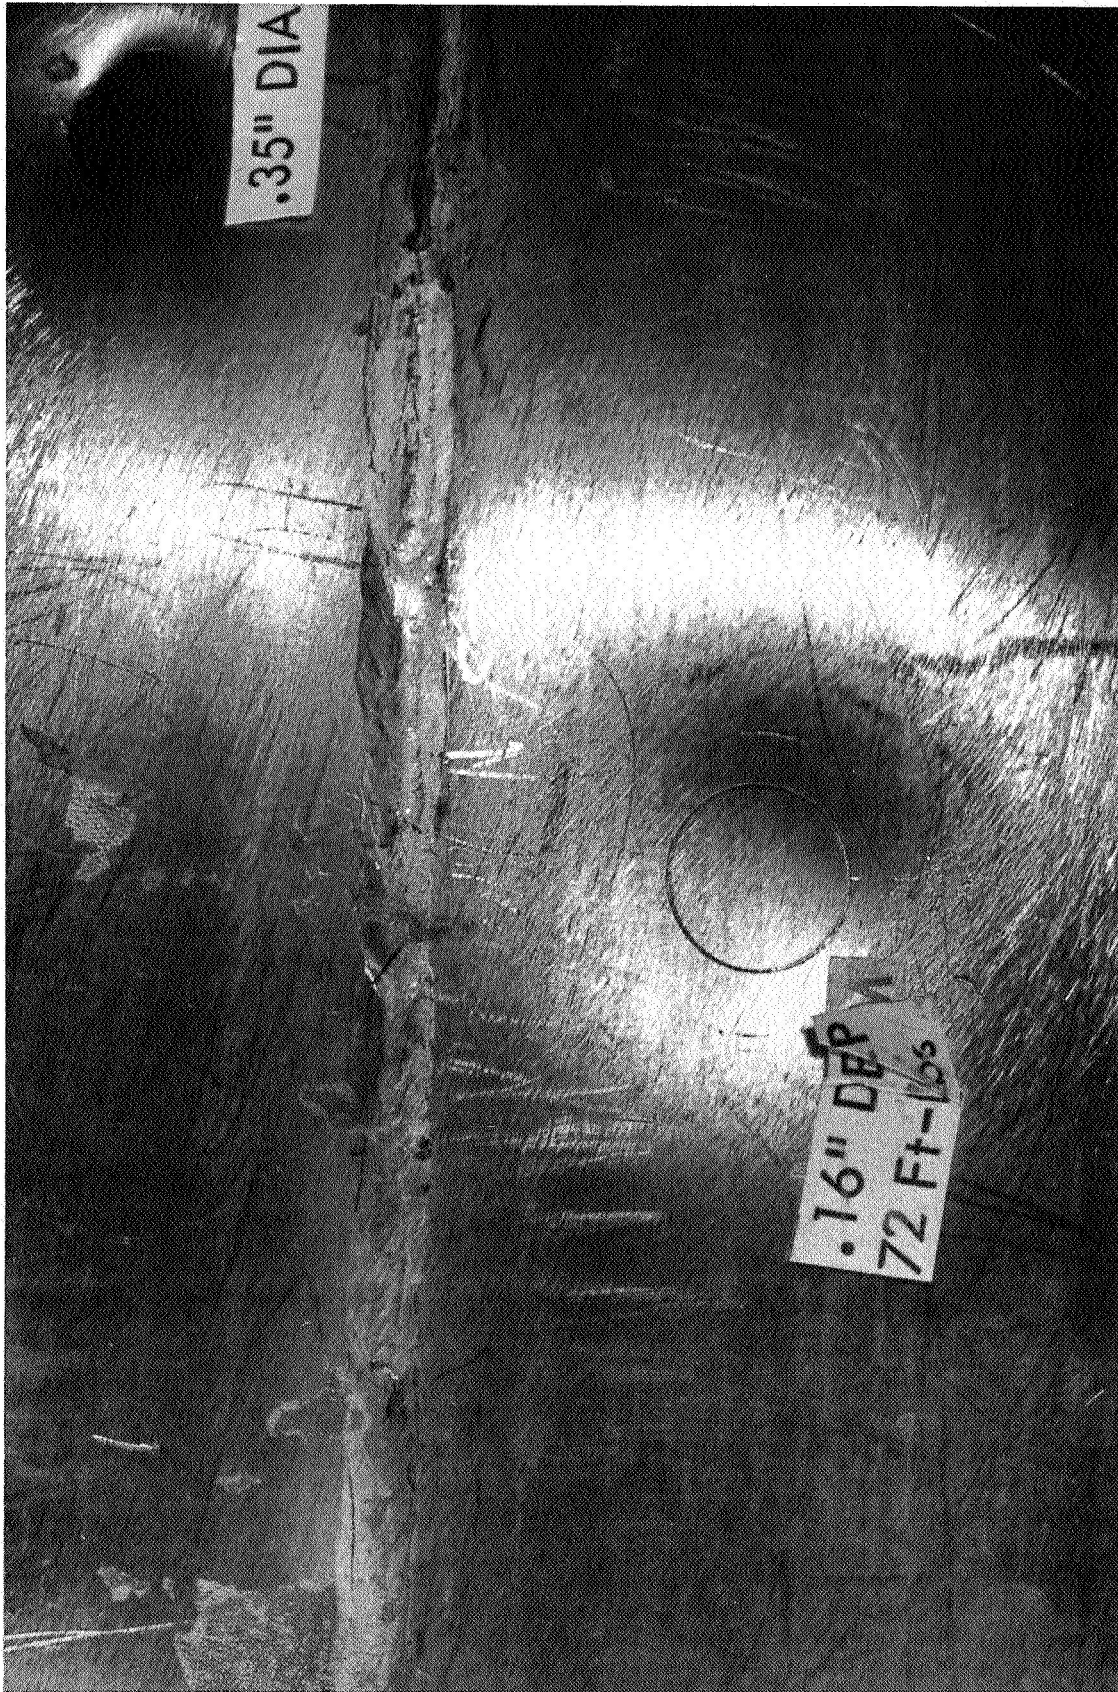
FIGURE 42 MYLAR TANK AFTER BLUNT IMPACT -- 72 FT-LBS.

Blunt Impact - Blunt impacts to the exterior of the propellant tank at levels up to three times the ABMA acceptance level caused no reactions or material ignition of either the Mylar or Kapton bladders. The impact areas on each tank are shown in Figures 42 to 48. The deformation of the test tank containing the Mylar bladder was 0.016, 0.31 and 0.48 respectively for impacts of 72, 144 and 216 ft-lbs. The second tank assembly (containing the Kapton bladder) experienced deformations of 0.10, 0.35, and 0.45 under an equivalent series of impacts. No leakage was detected in either the tanks or the bladders after the impacts and, with the exception of the deformed impact areas, the structural integrity of the tanks remained intact. In both tests a rapid boil-off of cryogen was experienced after each impact from the addition of energy to the system.

From the blunt impact tests, it is evident that even under severe impact loads to the propellant tank the polymeric bladders do not experience sufficient energy to cause spontaneous bladder ignition.

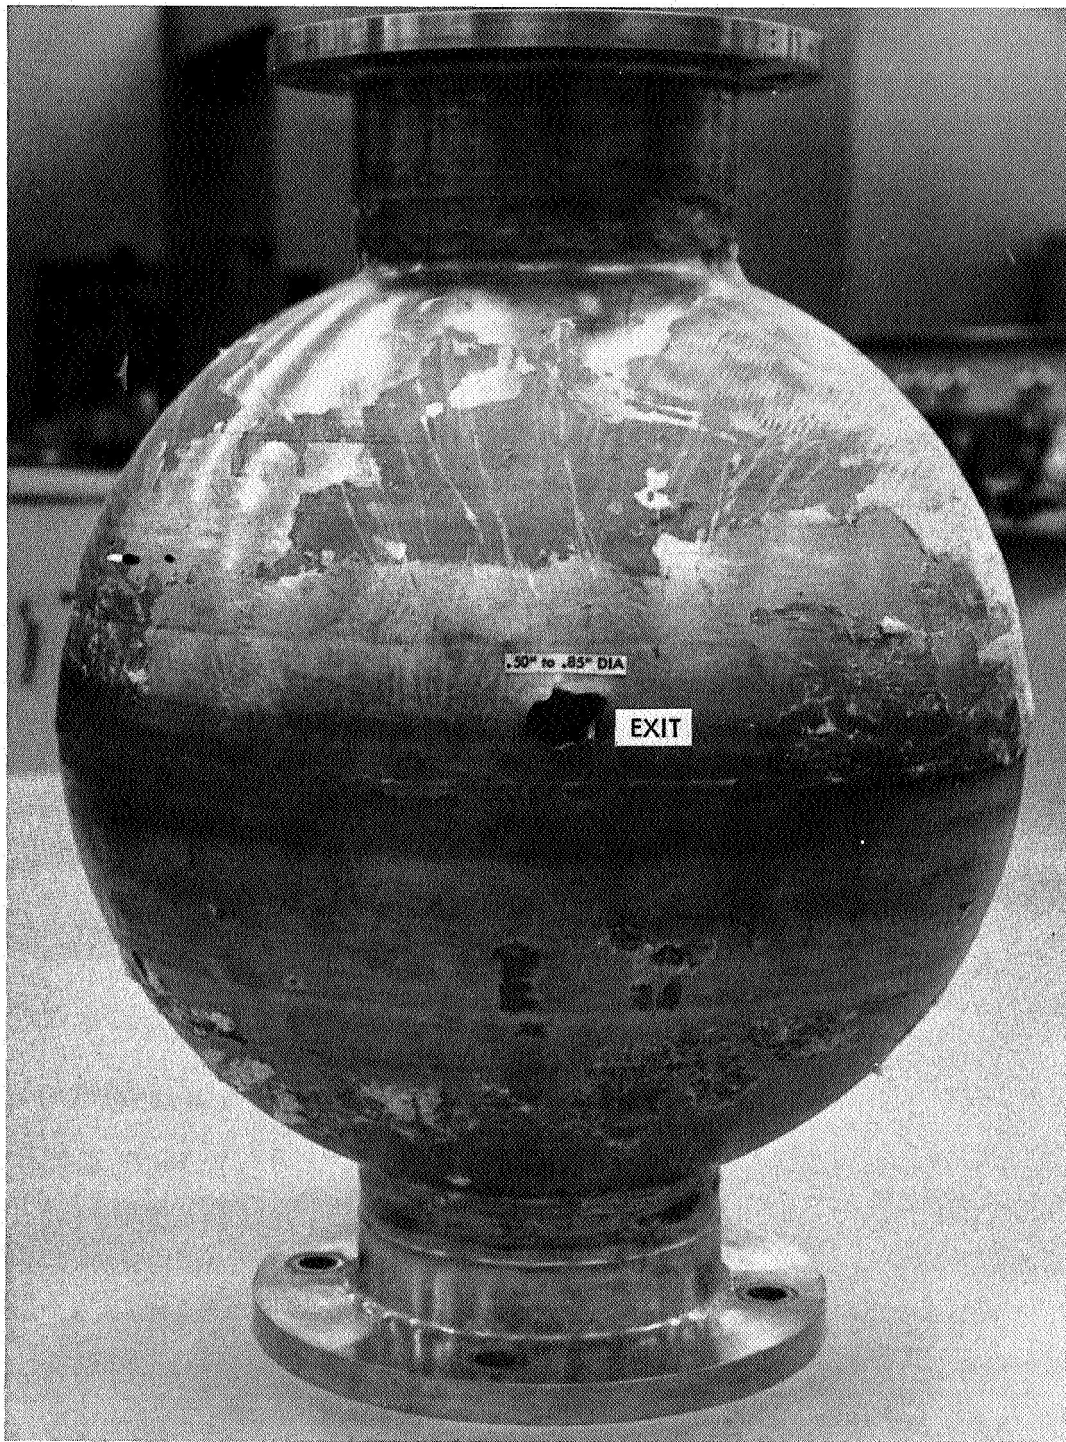
FIGURE 50 MYLAR TANK AFTER BALLISTIC PENETRATION — EXIT

FIGURE 51 MYLAR TANK AFTER BALLISTIC PENETRATION — EXIT

Ballistic Impact - In the evaluation of the Mylar bladder, the projectile entered the tank approximately one inch above the centerline of the tank as shown in Figure 49, puncturing a hole 0.35 inch in diameter. The projectile continued through the tank, nicked the standpipe and penetrated the back wall approximately one inch above center. The exit hole, 0.50-0.85 inch in diameter, is shown in Figures 50 and 51.

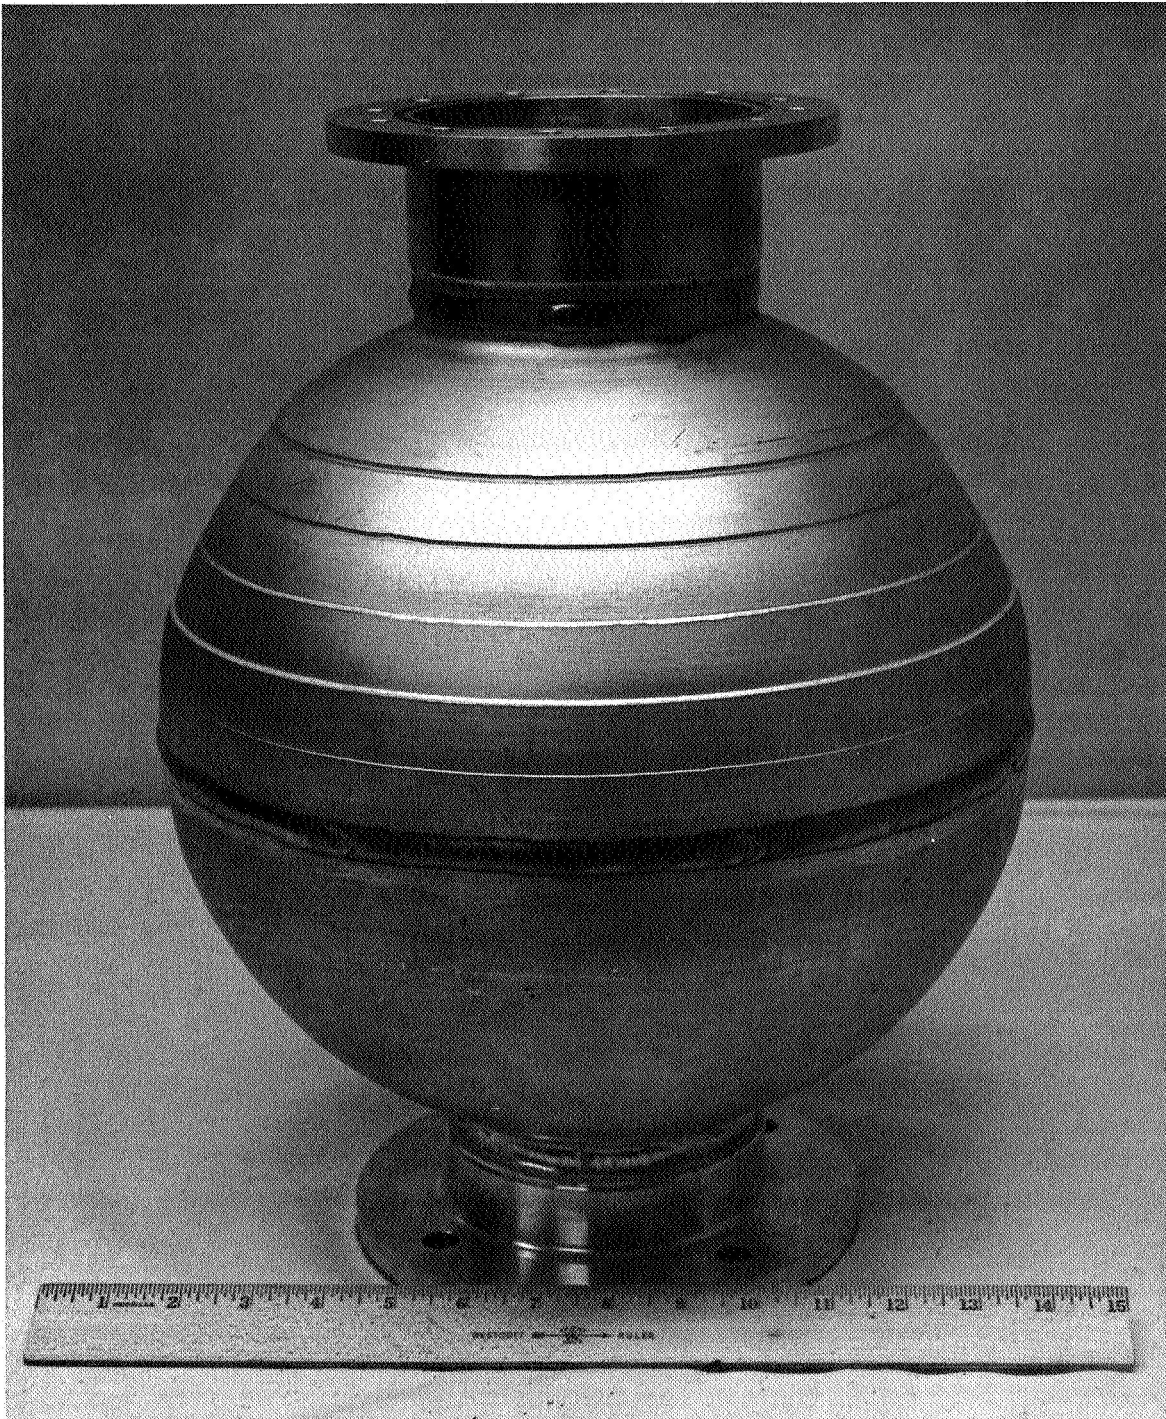
FIGURE 58 ALUMINUM TEST TANK WITHOUT FITTINGS

The tank, shown in Figure 58, was identical to the stainless steel tanks (Section 3.2.4) used throughout Task II and the previous portion of Task III with the following two exceptions:

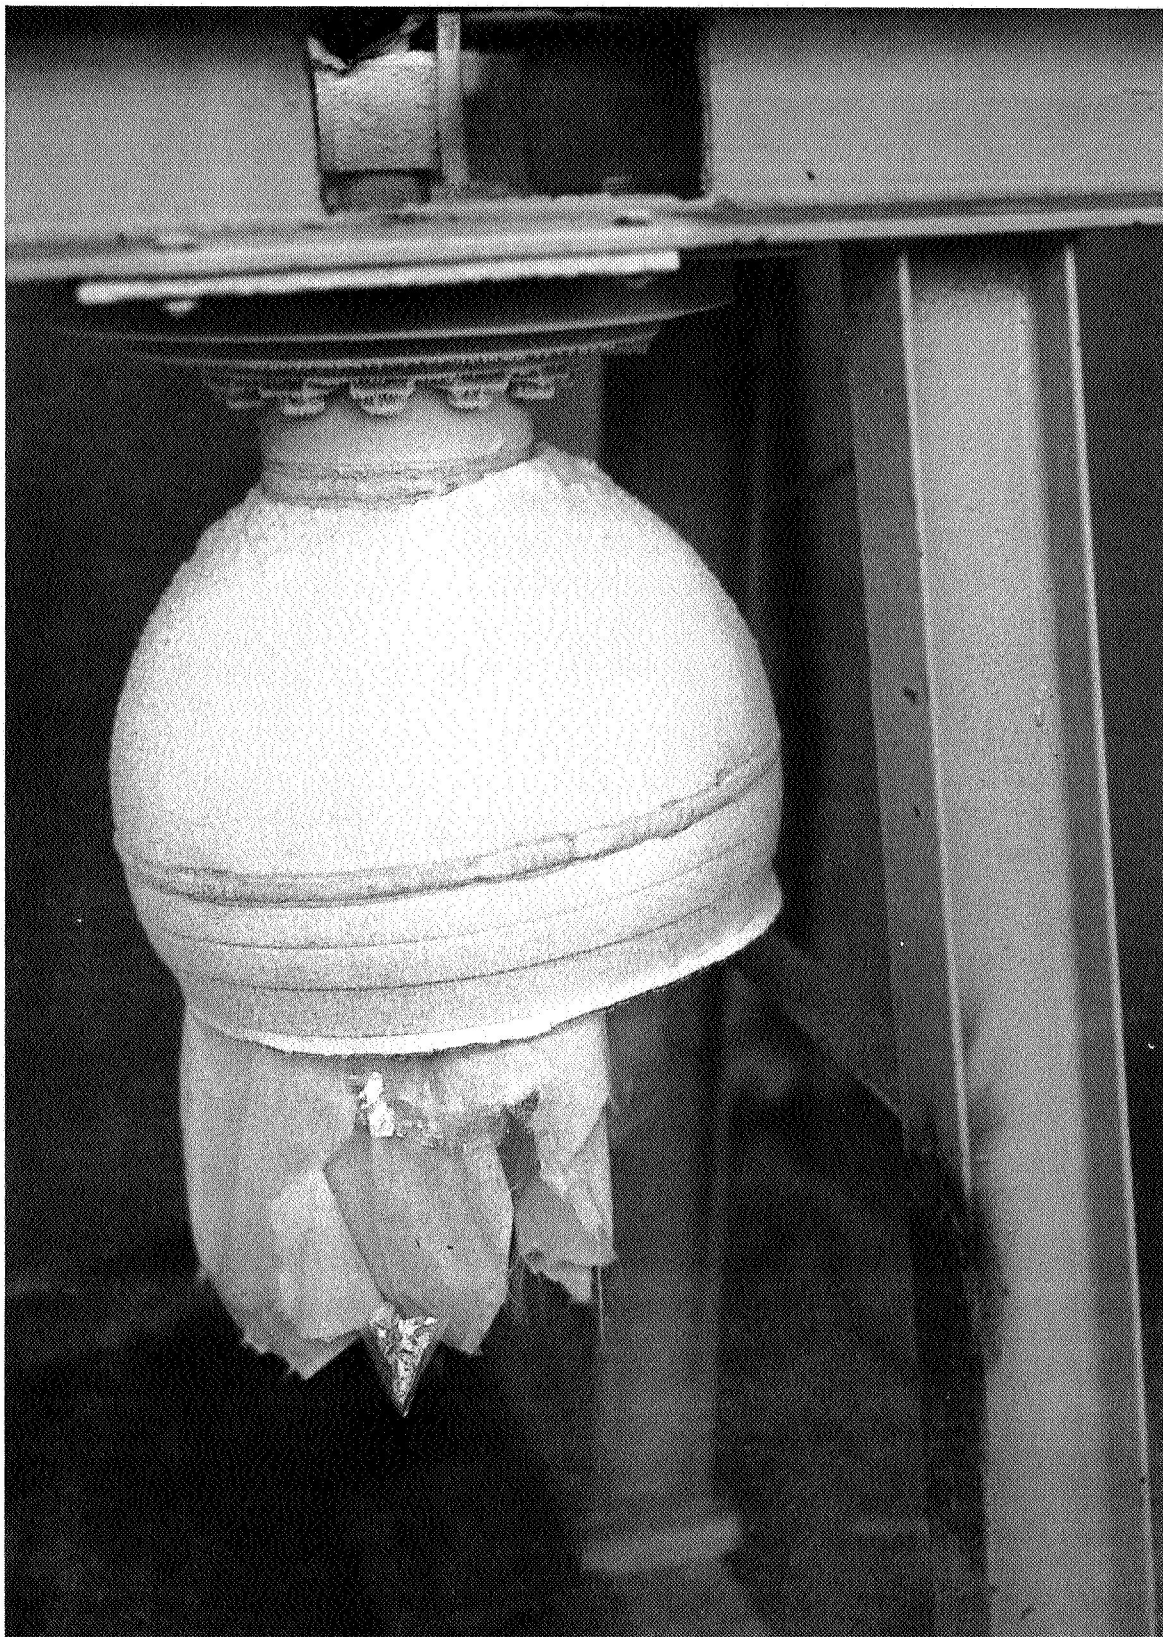
FIGURE 61 MYLAR BLADDER AFTER BURST TEST

No sign of liquid oxygen incompatibility (no charring or ignition) was noted on either bladder or tank. Both bladders experienced extensive damage (Figures 61 and 65) as one would expect. The damage was concentrated in the burst area with a considerable amount of crack propagation and tearing radiating from the area.

3.3.4.4 Test Results - The first tank, containing the Mylar bladder, burst at a pressure of 123 psi (-297°F) and the second tank, with the Kapton bladder, failed at 126 psi (-297°F). Figures 60 to 68 show each tank/bladder assembly after test.
